Assessment of the Vapor Phase Catalytic Ammonia Removal (VPCAR) Technology at the MSFC ECLS Test Facility

Kristin Tomes, David Long, and Layne Carter
NASA Marshall Space Flight Center

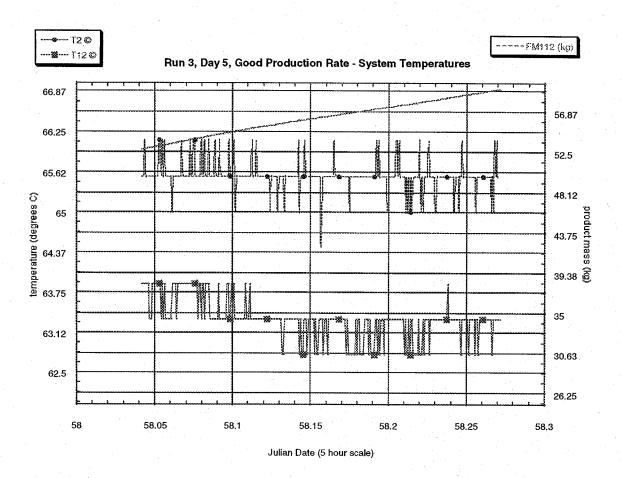
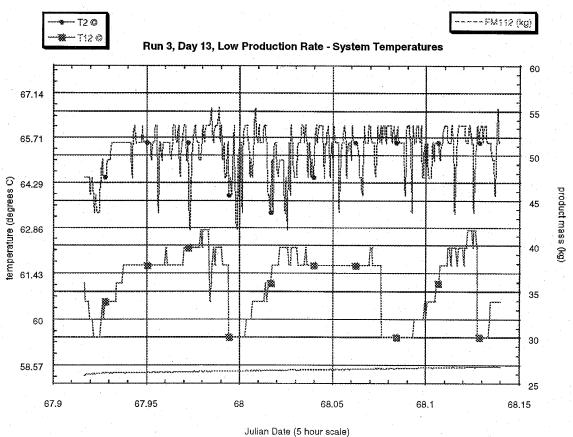
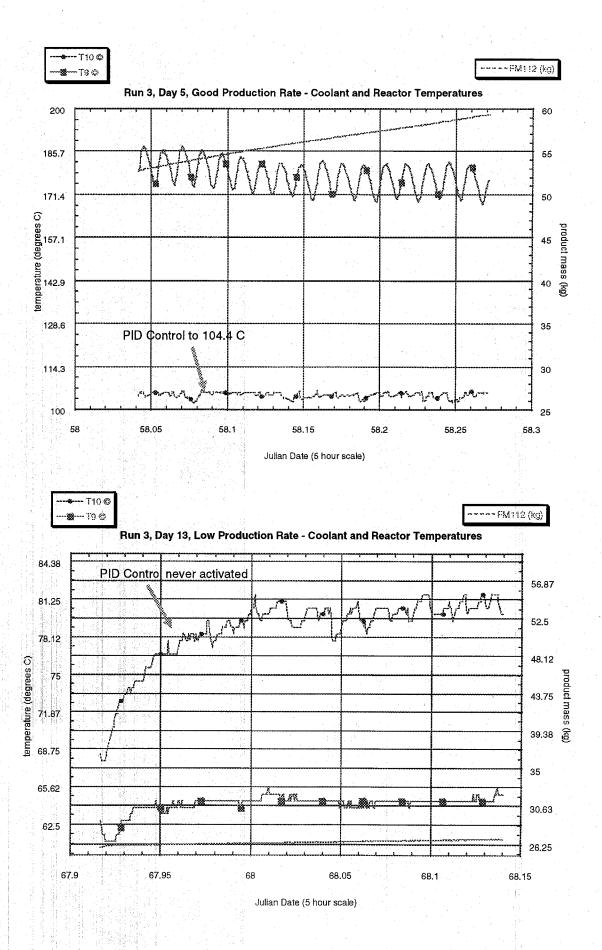
Figure 7. Comparison of System Temperatures during Good and Low Production Periods

As with the previous two tests, pressures and temperatures decreased and did not return to their initial operational values. Figure 7 shows plots of T2, T12, T9, and T10 during a 5 hour operational period of good production rate as compared to a 5 hour operational period of low production rate.

T2, which is the temperature of the feed before entering the WFRD, varied a small amount between good and low production times. This is due to the fact that facility software was set to control the feed temperature to 65.6 C (150 F). T12, however, is the temperature inside the WFRD that dictates when the solenoid valve will open to allow flow to the product tank. As can be seen, T12 dropped approximately 1.5 C when the production rate decreased.

T9 is the temperature of the oxidation reactor effluent stream before entering the Water Reuse Technology Heat Exchanger (WRT HX). During normal production this temperature cycled around 176.7 C (350 F). However, once production rate began to drop, T9 dropped to just under 65.6 C (150 F). T10 is the temperature of the oxidation reactor effluent as it leaves the WRT HX and which is used to control the coolant flow through the WRT HX. Facility software is set to control this temperature to 104.4 C (220 F) which is done during normal operation. Once production rate dropped, T10 never exceeded 82.2 C (180 F) thus not requiring coolant to enter the system.

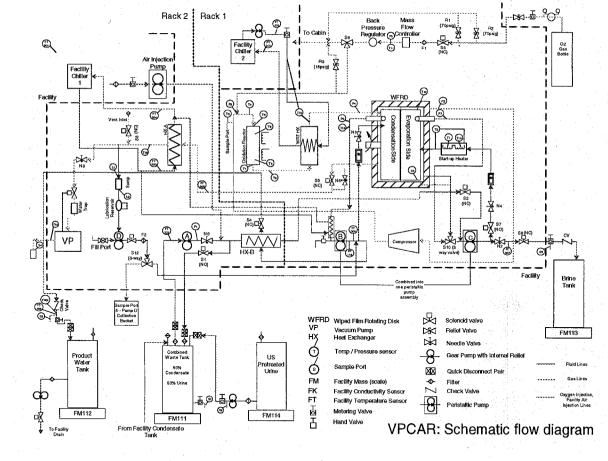
Figure 9. Final Configuration VPCAR Schematic Flow Diagram

Several modifications were made to both hardware and software to improve the operation of the VPCAR or to insure the test configuration properly assessed it as a candidate ELS technology. Throughout system checkouts and testing there were various components that failed and were repaired or replaced. Hardware failures did occur to ancillary components that are not related to VPCAR design, but are addressed herein for completeness. Some failures are indicative of design issues and are further addressed as such. Figure 9 shows the final system schematic at the end of testing with all modifications included.

System Modifications - WRT HX Coolant Flow - The V1 valve regulating coolant flow through the WRT HX did not function properly when the hardware was received. The coolant is supposed to regulate the fluid temperature just downstream of the WRT HX to 104.4 C (220 F); however the valve did not open properly to do this. The V1 valve was replaced with a metering hand valve and gear pump that was controlled by facility software to maintain a temperature around 104.4 C (220 F).

Gravity Sump Control - Originally the software caused the gravity sump to empty to the brine tank each time L3, the float valve inside the sump, went high. This did not allow the system to maintain its desired concentration level because of the quantity of brine leaving the system. Software was modified to return the gravity sump into the feed stream instead of dumping to the brine tank. However, if L3 remained high for more than 20 seconds.
